The Structure Health Monitoring for Identifying the Damping Performance of Building Structures under Strong Ground Motion on March 11 in 2011

I. Nishimura

Dep. of Architecture, Tokyo City University, Japan

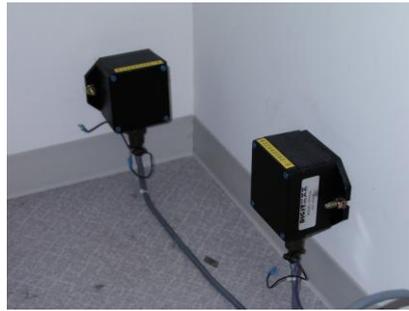
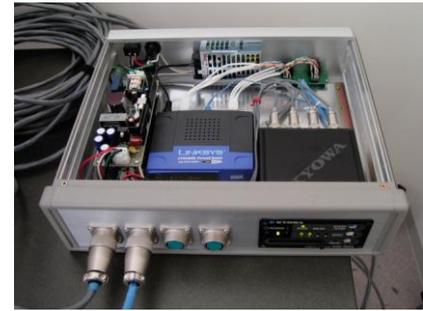
Figure 1.5 Equivalent Voigt Model **Photo 1.1** Accelerometers

There were two noticeable events shortly after the author research team started observation using the network sensors. One of them occurred on 23 July 2005, whose epicenter is located about 50km east of Tokyo and recorded magnitude 6.0 and intensity 5 according to JMA scale. Another one occurred about 300km away from Tokyo on 16 August 2005 with magnitude 7.2 and JMA intensity 4. The observed acceleration data on the ground floor are shown in Figure 1.12, and Figure 1.13, respectively. The acquired response acceleration histories on the 3rd floor are shown in Figure 1.8 and Figure 1.9, respectively. There are also shown transfer functions of 3rd floor from ground floor for each event. Even though the intensity levels are different, there is noticed little difference between the two transfer functions. Using the observed ground data and a simple Voigt Model shown in Figure 1.5, we can simulate the 3rd floor acceleration responses shown in Figure 1.10 and Figure 1.11. The participation coefficient factor at the 3rd floor with respect to the first mode is 1.10 according to the FME analysis. The damping factor in Figure 1.5 is determined by considering the participation coefficient 1.10.
